Inspection Certificate

Nro: FI9111 / F2OP236X

We were commissioned to inspect a 1993 Mercedes Benz 220 CE by Mr.Toivo Mäkelä. The objective was to clarify the condition and present market value of this vehicle.

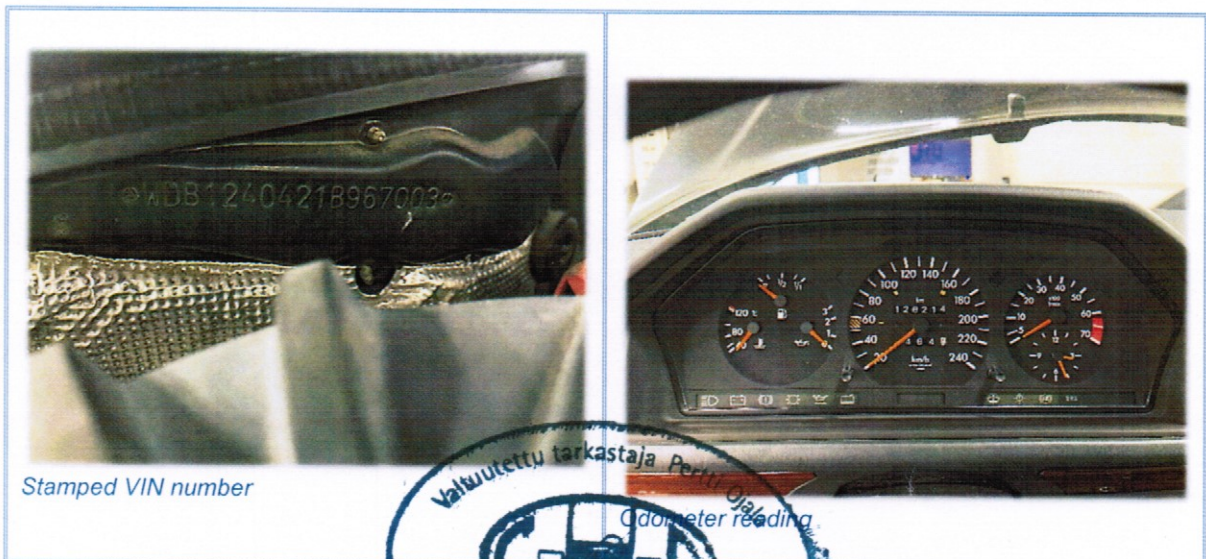
Stamped VIN number

Vehicle identification number (VIN) WDB1240421B967003 can be read from the engine compartment and it matches with the registration documents and other original documents.

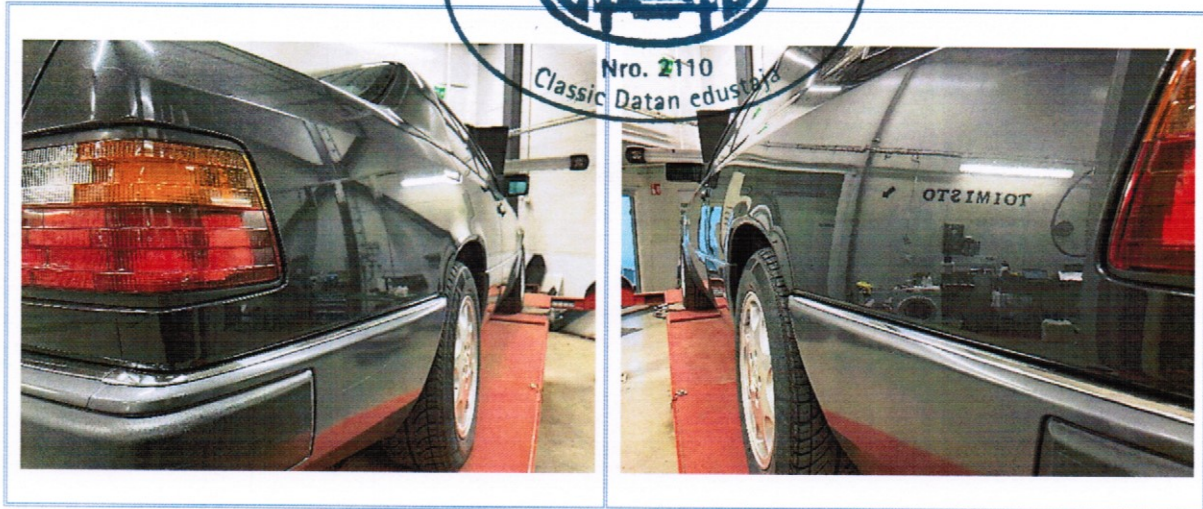
5.3.1 Vehicle Body

The car body looks excellent from a distance and closer look confirm that the paint surface is in very good condition. There are no signs of rust anywhere in outer body. All the doors and lids fits nicely with the body.

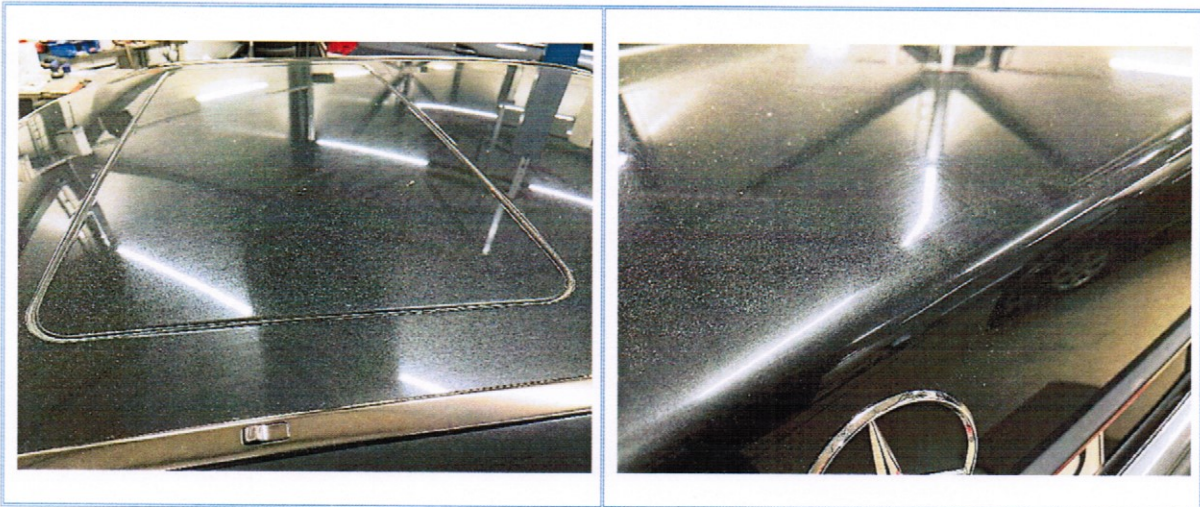
5.3.2 Paintwork

The condition of paint surfaces matches to the original quality. The thicknesses of the paint surface were within the manufacturer's values (120 – 370). The paint surface has minor traces of wear and micro-scratches caused by washing, which could easily be removed by mechanical polishing. The paintwork is original and no signs of repainting are visible.

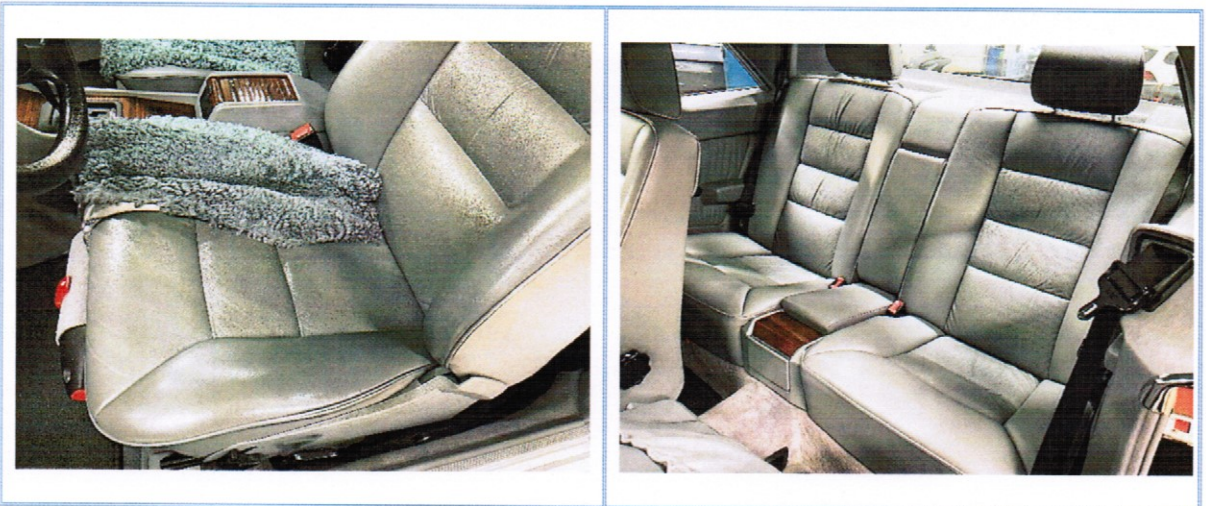
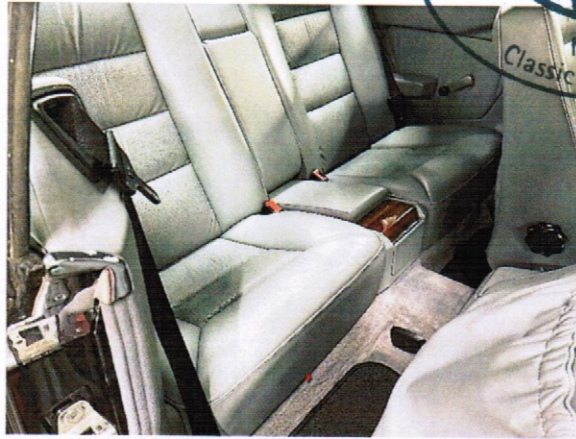
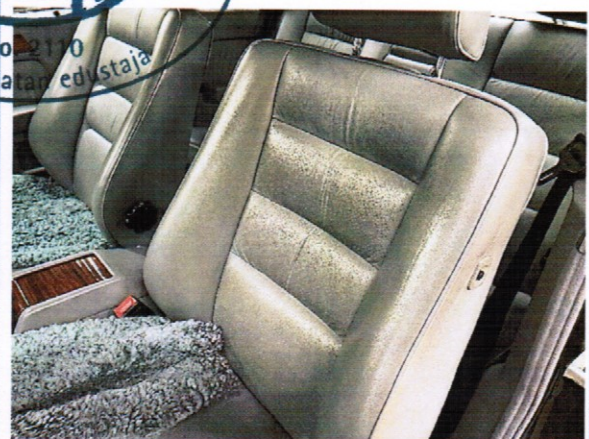
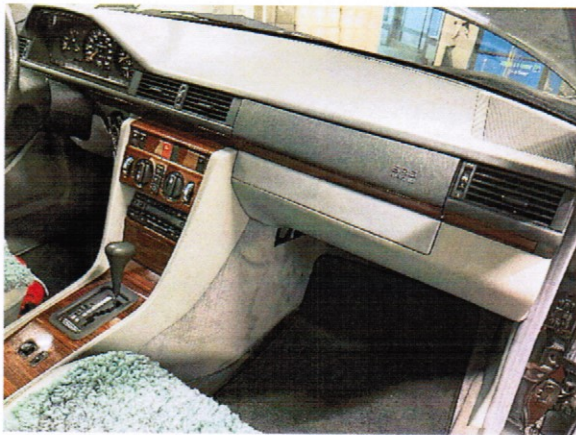
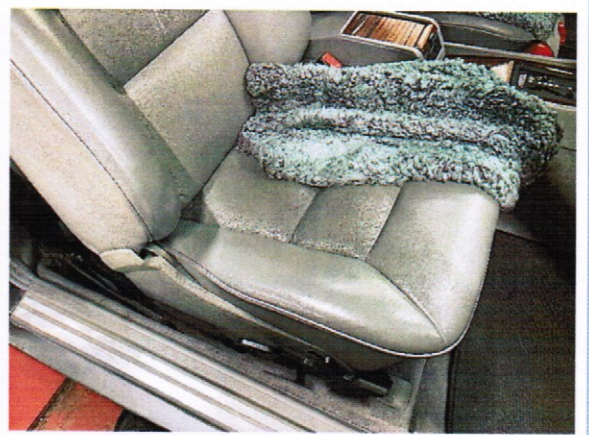
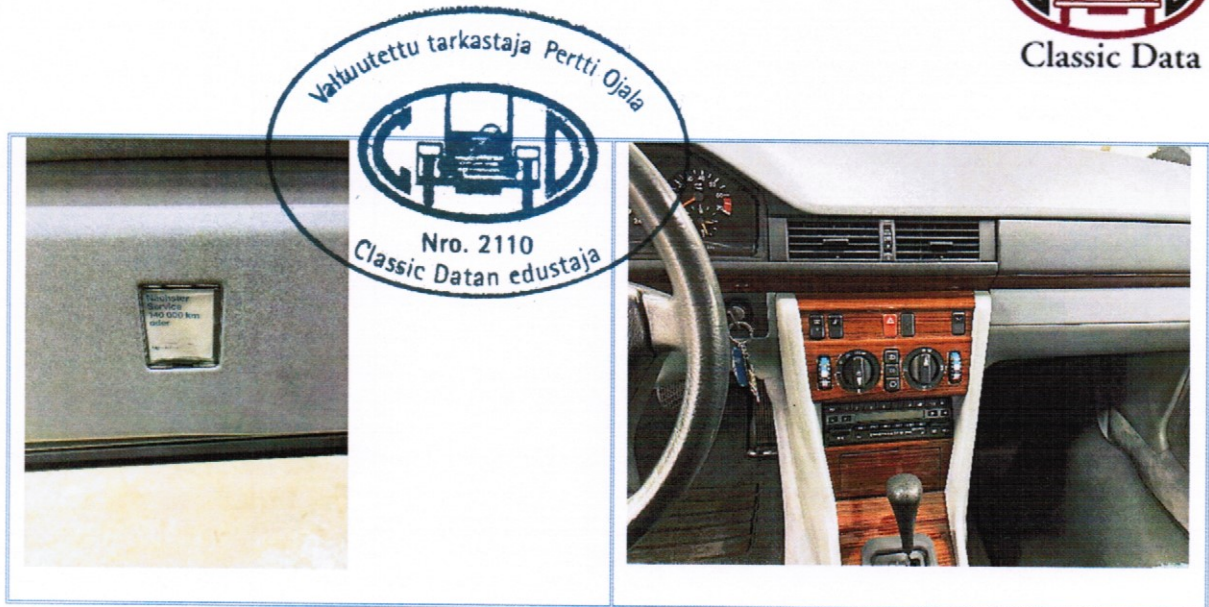
5.3.4 Interior

The interior is in very good condition. The front seats have always been protected with the seat covers shown in the pictures, and the benches under them are in like-new condition. The back seat looks untouched, so it's hardly ever been sat there. The service book is filled out in your place so that the next service is visible.

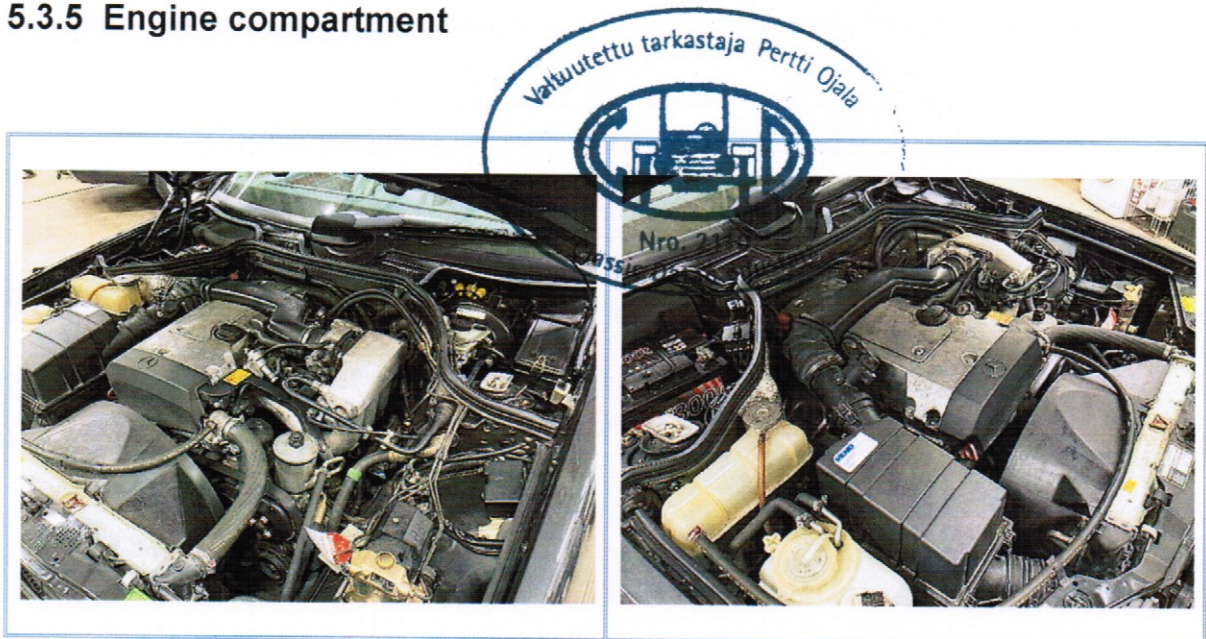
5.3.5 Engine compartment

Engine and engine compartment is in original condition and there are no any visible leakages. Engine started and running smoothly at idle and during test drive has not been detected any blue smoke or abnormal characteristics as well as performance was original.

Engine and engine compartment is in original condition and no any visible leakages. Engine and it's all equipment have been carefully cleaned.

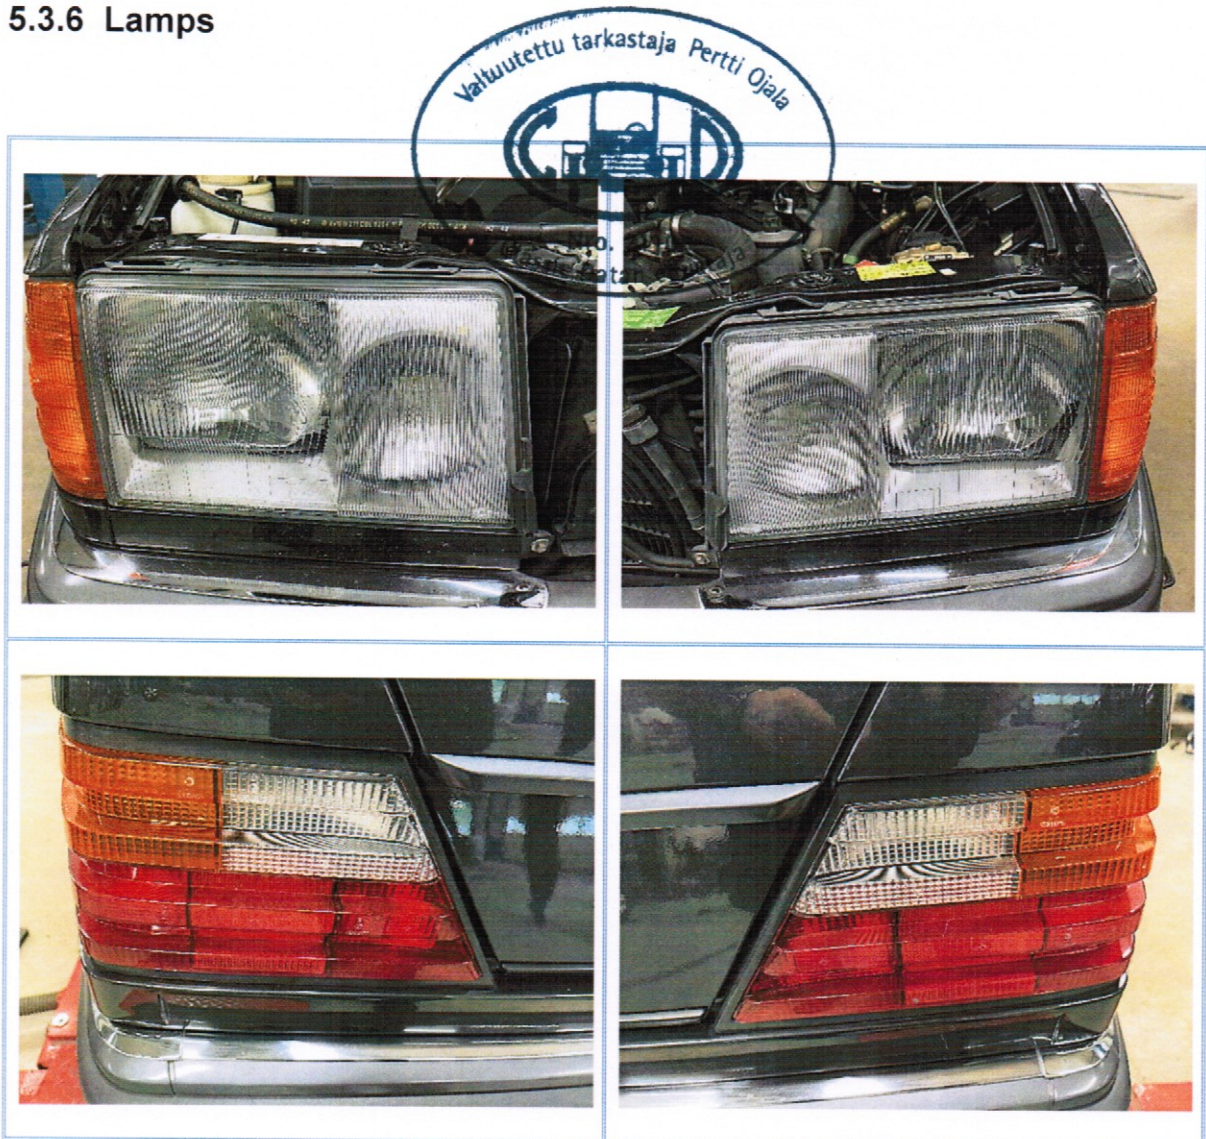
5.3.6 Lamps

All lamps and lamp glasses are in good original condition.

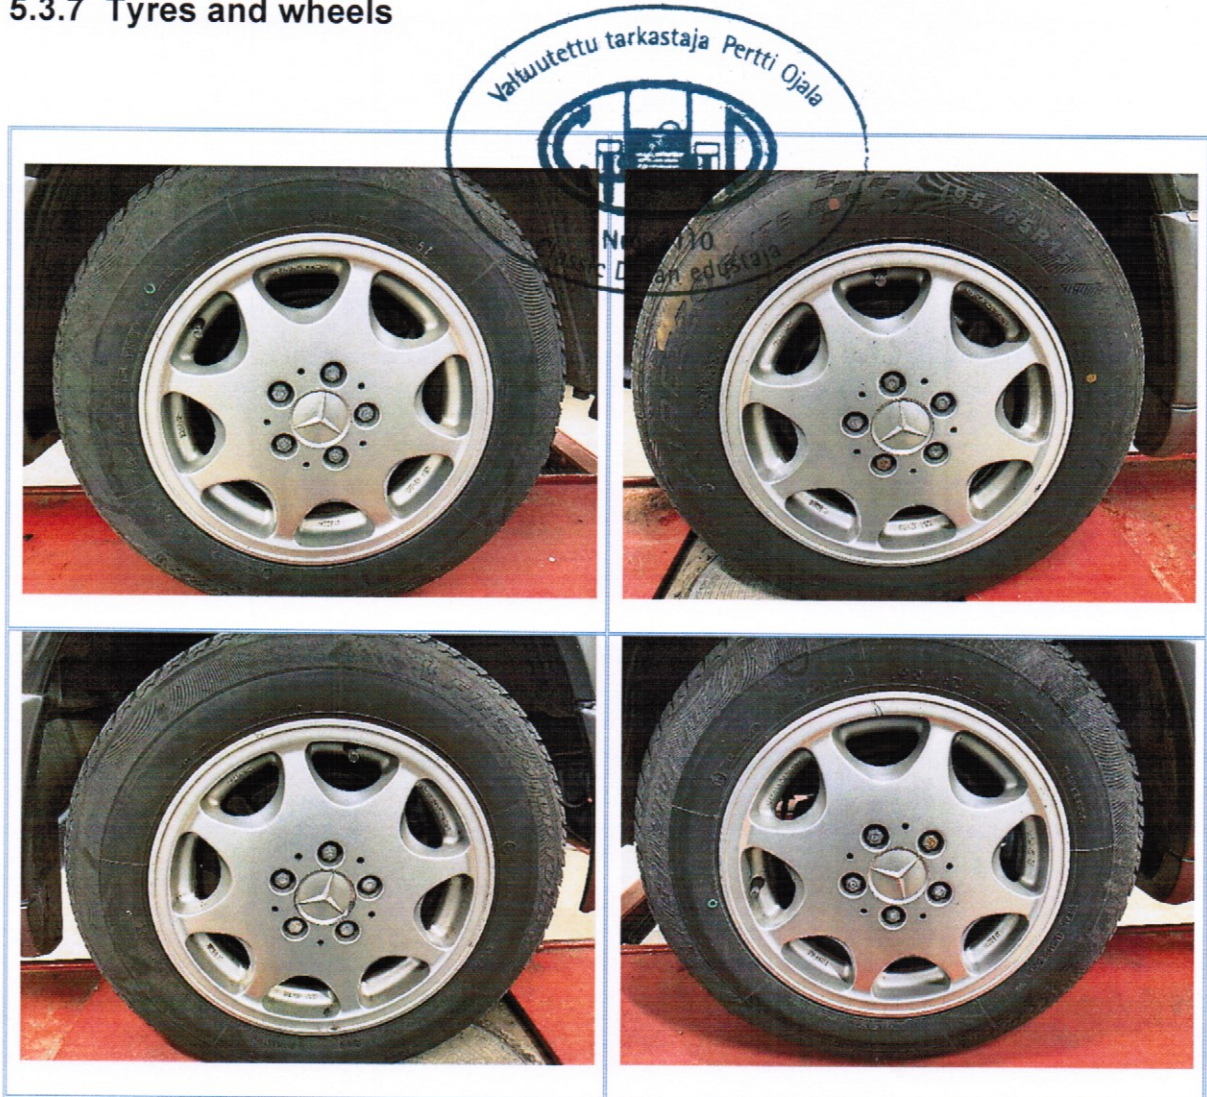
5.3.7 Tyres and wheels

The tires and wheels are in good condition and there are no scratches or dents on the wheels.

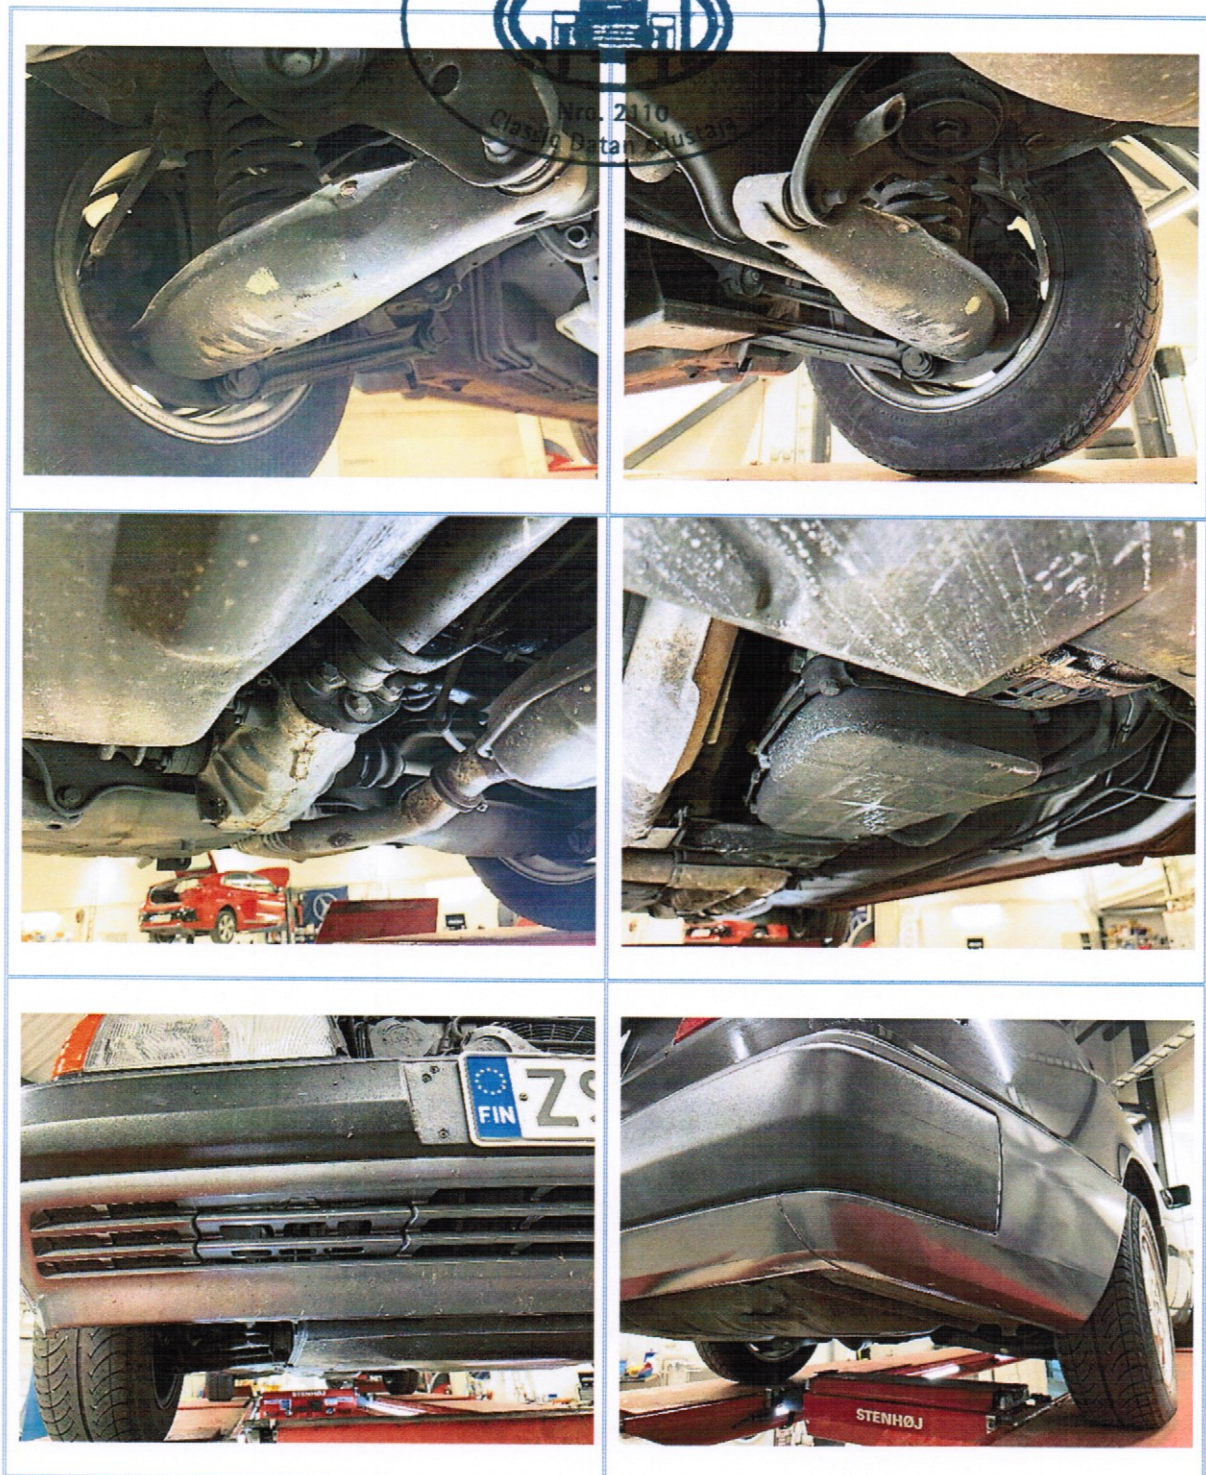
5.3.8 Chassis

The chassis of the car is also in good condition and there are no leaks anywhere on the chassis, there are no traces of being hit. The edges of the bumpers, both front and back, are in good condition and there is no stone chipping.
